March 15, 2013

Fulton County Commissioners  
Attn: Dan Swain  
116 West Market Street  
McConnellsburg, PA 17233

Subject: Meadow Grounds – Dam Inspection

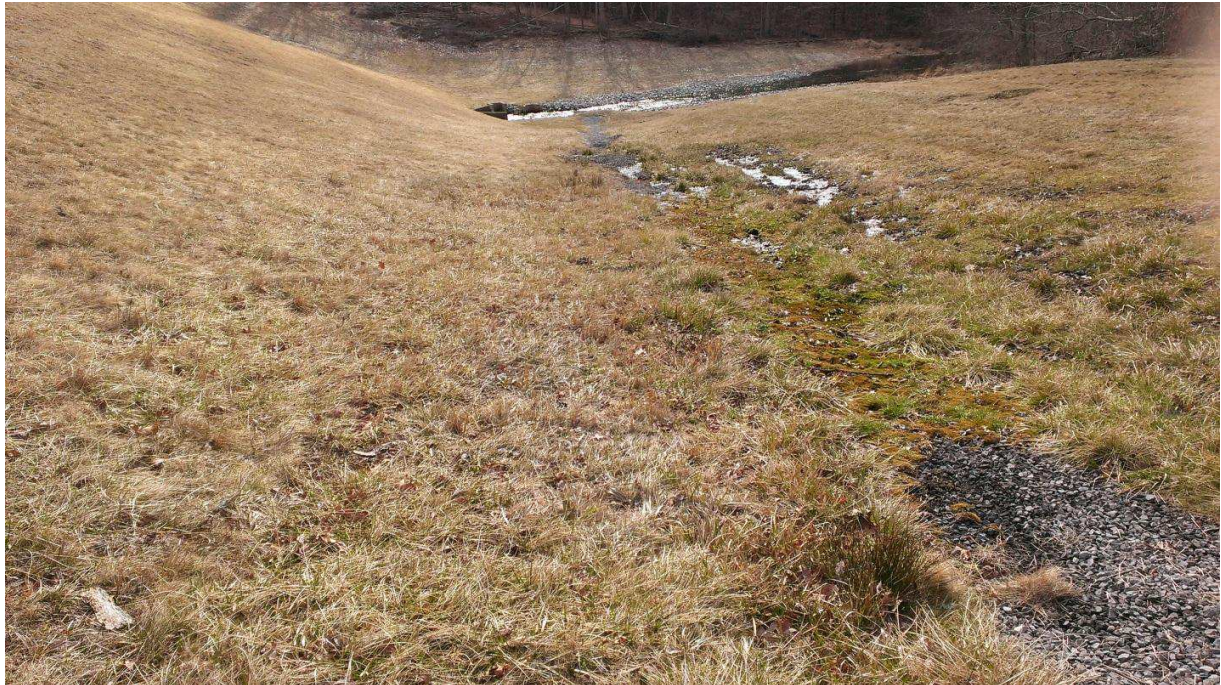
The only significant dam structure issue determined during the investigation was a moderate wet/seepage area found on the west side of the embankment that was located on the downstream face of the dam at a

point about 2/3 of the height of the dam and along the natural raised terrain on the western side of the dam. This area is shown on the photograph below and is illustrated on the attached referenced report.

Seepage/wet area on west side of embankment

At this location, the ground was soft and showed visual signs of long term seepage. The ground vegetation included moss and other wetland type grasses. The stone gravel seepage collection trench has been eroded from larger and assumed previous seepage rates that were not evident during the inspection. However, small collection pools of water downslope of the seepage area were observed during the inspection. It was noted that the pool elevation of the reservoir appeared slightly above the height of the opposing seepage area during the inspection.

From our observations, the west side seepage has not affected the alignment or stability of the dam by erosion or dislocation of dam materials at this time. The water from the seepage appeared to be clear and small in flow volume; however during normal pools the volume and turbidity may have been greater. We can only speculate at this however. Although it is noteworthy that the past inspection report by PFBC and PADEP dated December 21, 2012, indicate that that the seepage was clear at that time as well, and that a future action would need to be planned. We agree, over time, this seepage area could create a future issue for the dam embankment and should be addressed as soon as possible.

If reasonable and cost-effective steps to examine and repair the dam structure were to be performed now, a complete replacement of the earthen dam structure would probably not be required to alleviate concerns for dam safety. A much more economical fix, after performing the seepage analysis, would be the use of either a combination of relief wells, storage restriction, grouting and/or an upstream impervious blanket. From our observations, the main cause of seepage is probably occurring at the contact of the earthen embankment fill material and the prepared foundation/sidewall material.

If this speculation is confirmed by further analysis of the seepage, it could easily be addressed by either or both pressure grouting of the dam in this area, and/or an upstream impervious blanket on the reservoir side of the dam embankment. Preliminarily, the overall costs of installing clay at an approximate depth of 18" over an approximate length of 650' and an approximate width of 100' would be approximately \$100,000. These types of repairs are found in USACE EM 1110-2-1901 Chapter 12 "Remedial Seepage Control" and have case studies proving of their success.

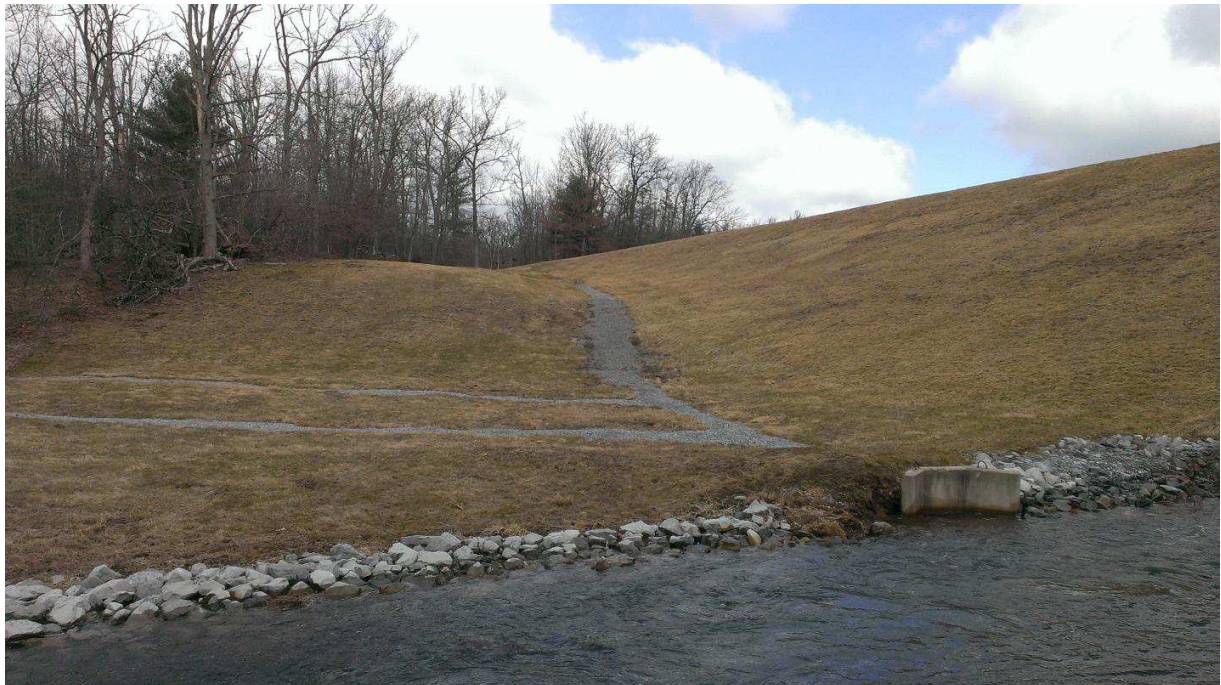
View of west side embankment
